Incidence of undetected cement on CAD/CAM monolithic zirconia crowns and customized CAD/CAM implant abutments. A prospective case series

Wasiluk G, Chomik E, Gehrke P, Pietruska M, Skurska A, Pietruski J. Incidence of undetected cement on CAD/CAM monolithic zirconia crowns and customized CAD/CAM implant abutments. A prospective case series. *Clin. Oral Impl. Res.* 00, 2016, 1–5.
doi: 10.1111/clr.12879

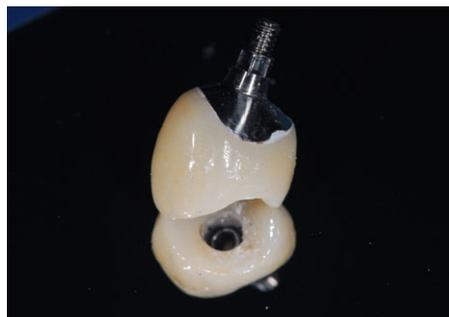
Fig. 1. Small cement residues on the abutment on which a crown restoring the bicuspid was cemented. The occlusal opening allowing post-cementation unscrewing of the abutment/crown connection is visible in the mirror reflection.

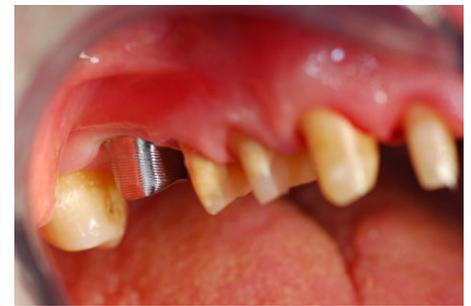
Fig. 2. CAD/CAM abutment screwed into implant before cementation procedure.

(if necessary) and re-screwed in final position using a defined torque of 25 Ncm. The occlusal openings of the ceramic crowns were filled with polytetrafluoroethylene tape and closed with a composite material (GC Corporation, Tokyo, Japan) (Fig 2–5).

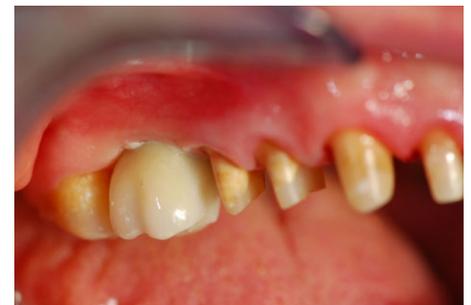
Fig. 3. Monolithic zirconia crown after cementation before cleaning.

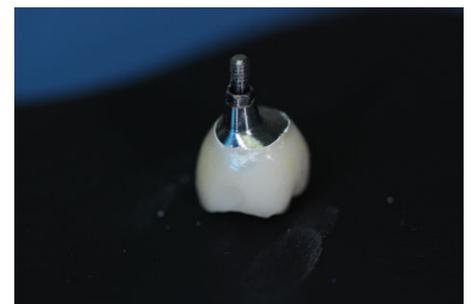
Fig. 4. Crown/abutment unit unscrewed after cementation. Cement excess visible on the surfaces of abutment and crown.

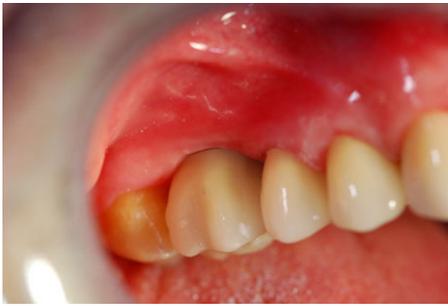
Fig. 5. Crown/abutment unit re-screwed after cleaning and polishing.

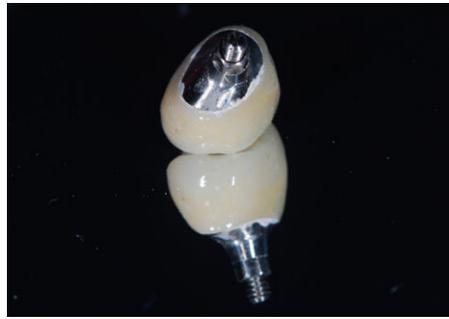
Fig. 6. Prosthetic reconstruction of the bicuspid. Typical linear shape of cement residues located along the abutment shoulder.

No cement remnants could be found at the surrounding peri-implant tissues, whereas clinically undetected cement excess was visible on 44 of 60 restorations (73.3%). No cement was noticed on 16 restorations (26.7%). The cement residues were located along the shoulder line of the abutment or/and crown. Linear assessment has shown that the cement residues were not expansive. Only in one case, they extended beyond the threshold of 2 mm distance from the shoulder toward the implant/abutment connection (Fig. 6, 7).

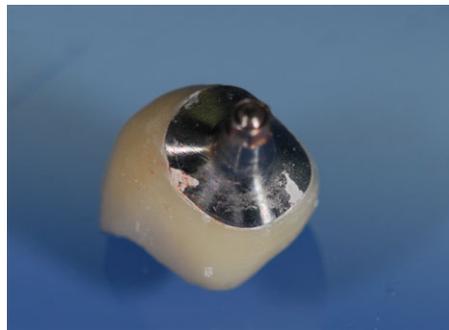
Fig. 7. Prosthetic reconstruction of the molar with the largest cement residues exceeding a 2 mm distance from the crown/abutment connection.
