# Facilitation of Full-Ceramic Implant Restorations in the Esthetic Zone: Utilizing Prefabricated Zirconium Copings on Corresponding Implant Abutments

author\_Peter Gehrke<sup>1</sup>, Germany & Marco Degidi<sup>2</sup>, Italy

This article summarizes a systematic restorative approach using a novel premanufactured zirconium abutment/coping system in partially edentulous patients. The prosthetic and laboratory procedures for an implant supported single tooth replacement in the esthetic region are addressed and illustrated in a step-by-step approach.

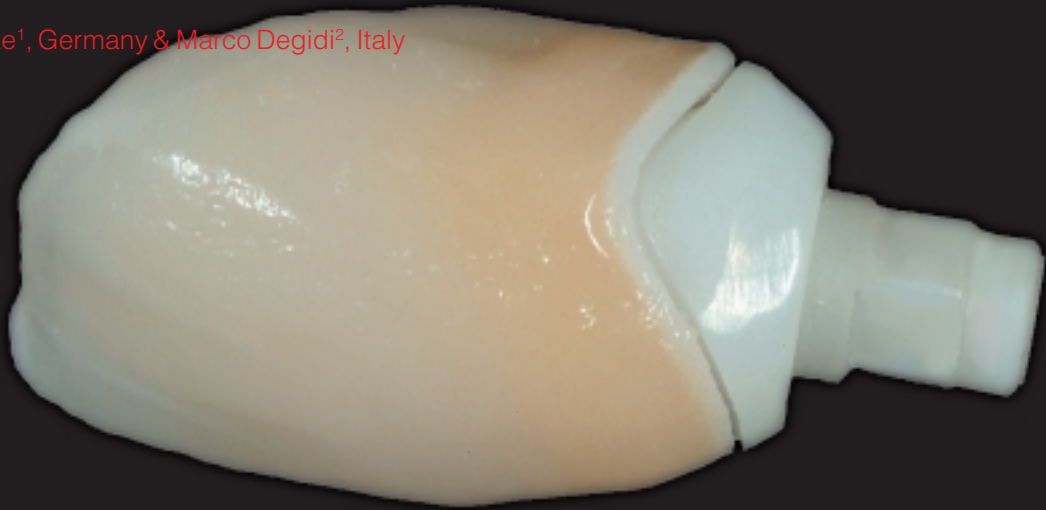
**Fig. 9** Finalized full-ceramic restoration in the laboratory. Coping served as foundation for porcelain crown.

Before pouring the cast, the zirconium abutment was connected to an implant analogue and securely reseated into the cap. No additional modifications were required and porcelain was applied directly to the ceramic coping to complete a full-ceramic crown. The coping served as the foundation for the porcelain applied by the laboratory to create the final restoration. No additional ceramic crown or wax-up is necessary. The full ceramic crown, based on the zirconium cap, was delivered and subsequently cemented with resin cement.

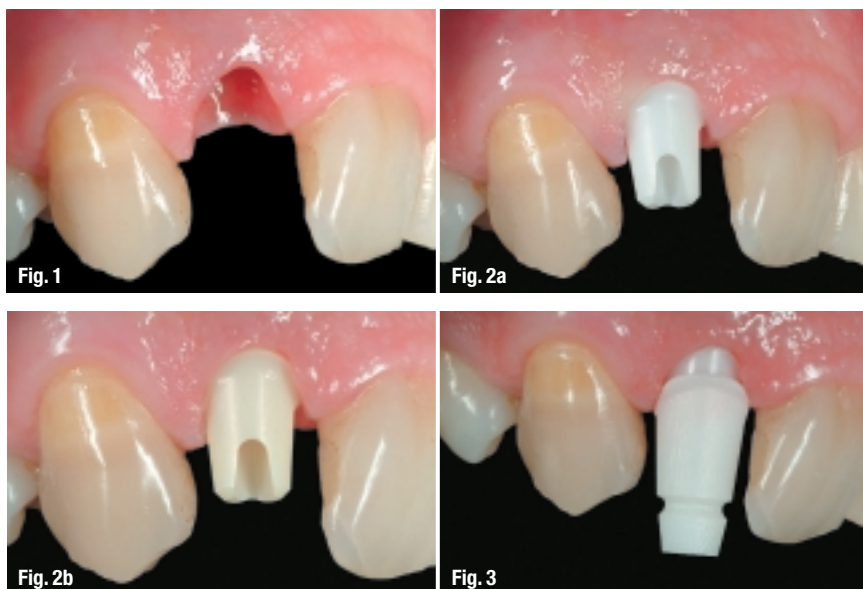
**Fig. 1** \_ Labial view after implant osseointegration (right lateral incisor) and stage-two soft tissue healing.

**Fig. 2a & b** \_ Try-in of zirconium ceramic abutments available in different shades (Cercon® neutral/Cercon dentin).

**Fig. 3** \_ Seating of Cercon Cap for impression taking.

After osseointegration and stage-two soft tissue healing, a zirconium-dioxide abutment (Cercon, Dentsply Friadent, Mannheim) was attached to an implant (XiVE®, Dentsply Friadent, Mannheim) replacing the right lateral incisor. After placing the abutment, a premanufactured corresponding zirconium coping (Cercon Cap, Dentsply Friadent, Mannheim) was seated and an impression was taken for the fabrication of a master cast. The ceramic coping serves as an impression transfer cap, to be picked-up directly with the impression.

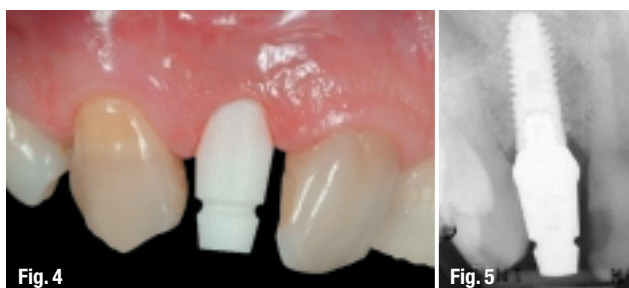
**Fig. 4** \_ Cercon Cap fully seated.

**Fig. 5** \_ Periapical X-ray of ZrO<sub>2</sub>-abutment/cap unit on implant.

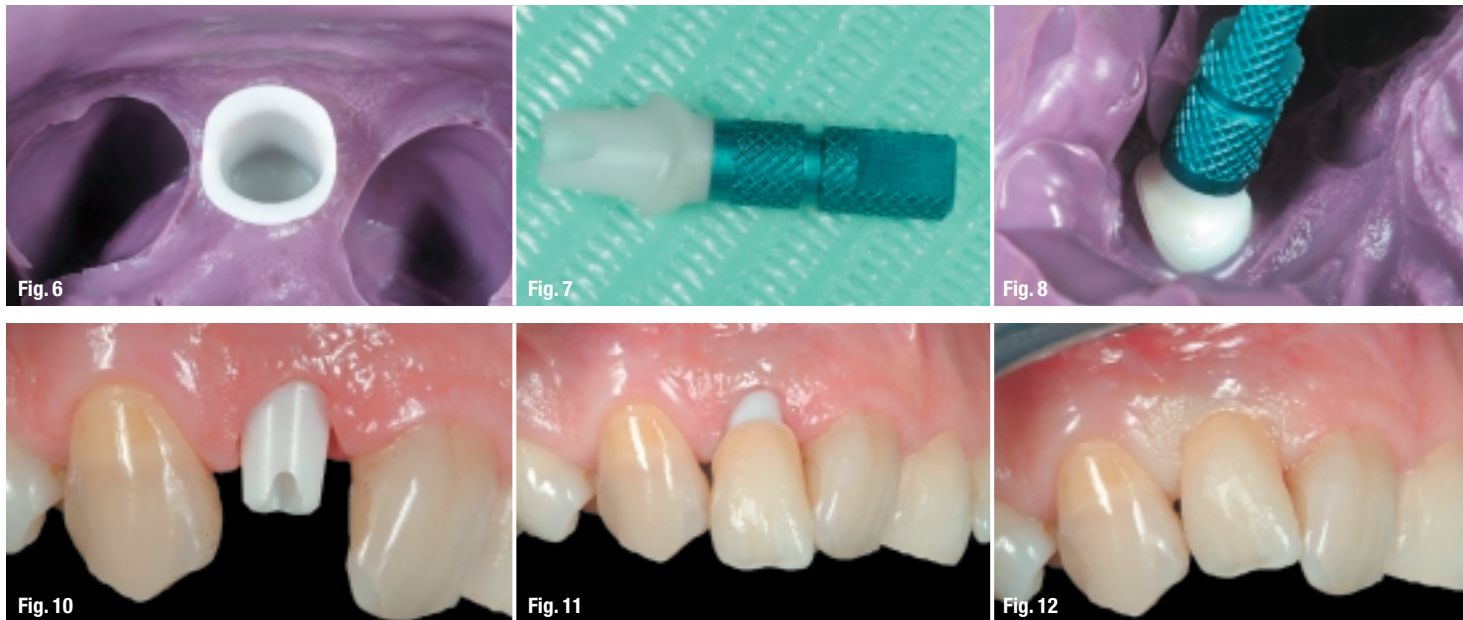
**Fig. 6** Impression with polyether material and picked-up Cercon Cap.  
**Fig. 7** Zirconium abutment connected to an implant analogue.  
**Fig. 8** Reseating of implant analogue/abutment unit into impression.  
**Fig. 9** Seating of zirconium ceramic abutment.  
**Fig. 10** Try-in of full-ceramic crown.  
**Fig. 11** Crown insitu immediately after cementation.

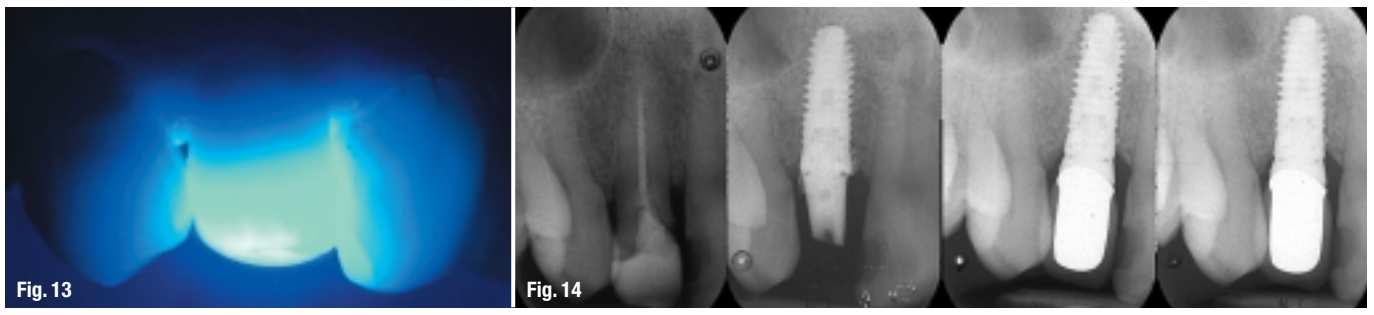
**Fig. 13:** Labial view of full-ceramic implant restoration with polymerization light. Note high translucency of restoration.  
**Fig. 14:** Treatment sequence in pre- and postoperative radiographs.
